Site No. 13

VAN ZANDT PIER

Newport
Van Zandt Avenue / Washington Street

Site Description

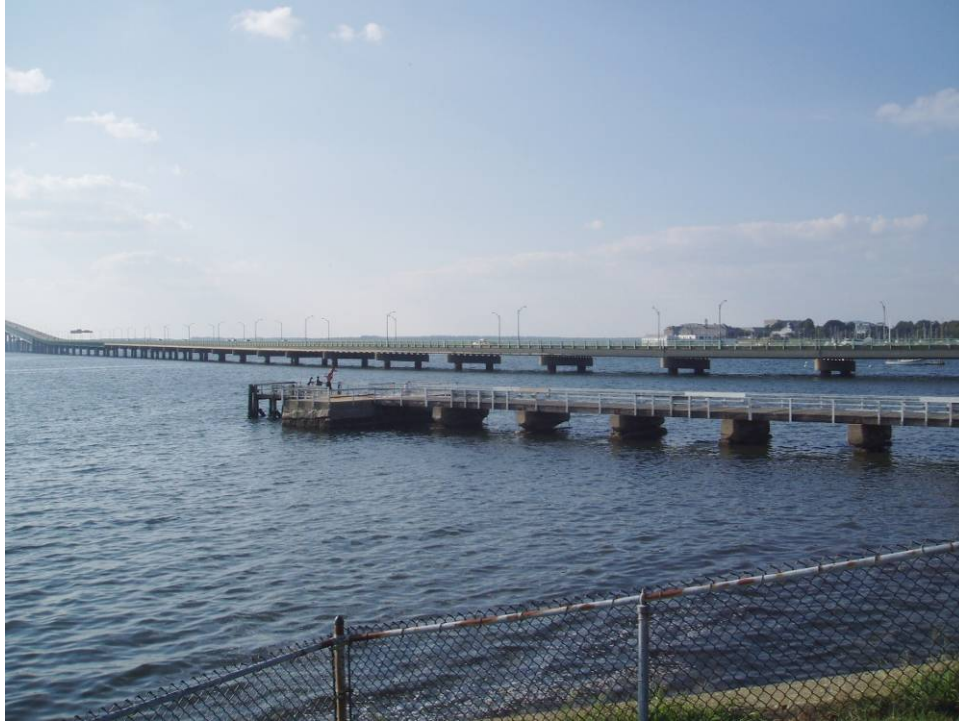
Photo 1. Van Zandt Pier looking northwest from Washington Street.

Van Zandt Pier is a hybrid concrete / timber / stone masonry structure which extends approximately 225 feet from the coastal seawall along Washington Street (Photos 1, 4, 8). The “cross” configuration at the end of the pier enhances its capacity for fishing use (see aerial photo), though the structure itself is not handicap-accessible due to the stairs that must be descended to gain access (Photos 4, 5, 8). Anglers interviewed at the time of visit were generally satisfied with the fishing access offered by the structure and the quality of fishing at this location. Several benches are provided along the sides of the pier, and the site and surroundings are kept clean and well-maintained by the Friends of Van Zandt Pier (as indicated on the trash receptacle at the pier entrance).

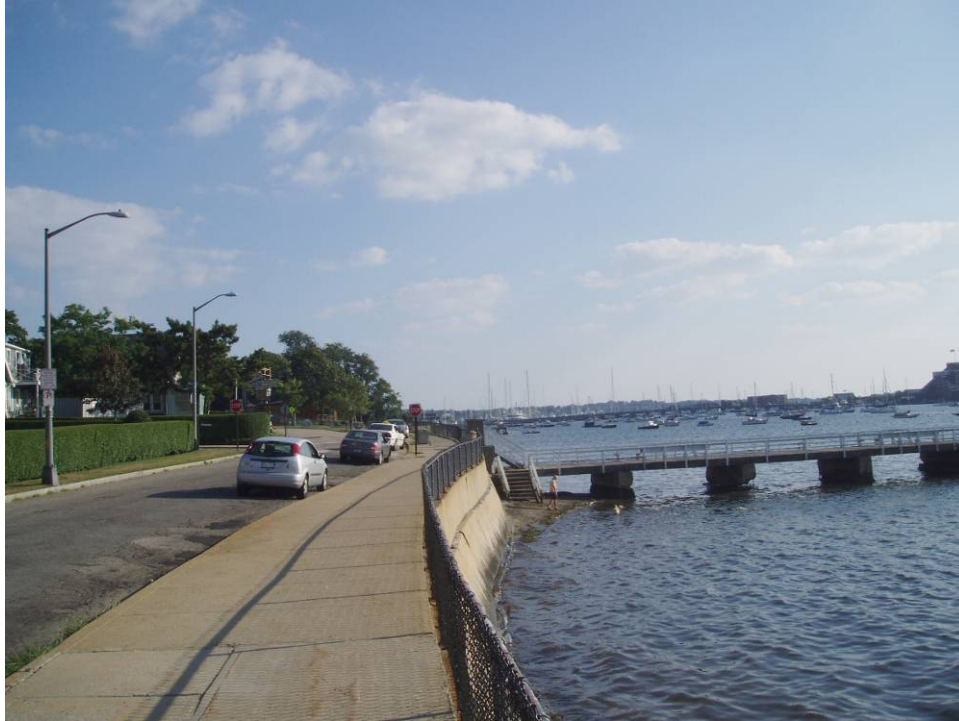
Photo 3. Looking south along Washington Street. Parking in this area is by resident permit only.

Environmental Constraints and Permitting. Van Zandt Pier is located along coastal waters classified by the CRMC as Type 2 (Low-Intensity Use), the coastal feature of which is the seawall along Washington Street at this location (Photo 3). Upon site visit, eel grass was observed both within the water and washed up on the shoreline. The density of eel grass in the vicinity would likely be problematic or prohibitive in permitting if any new or extended structure is considered.

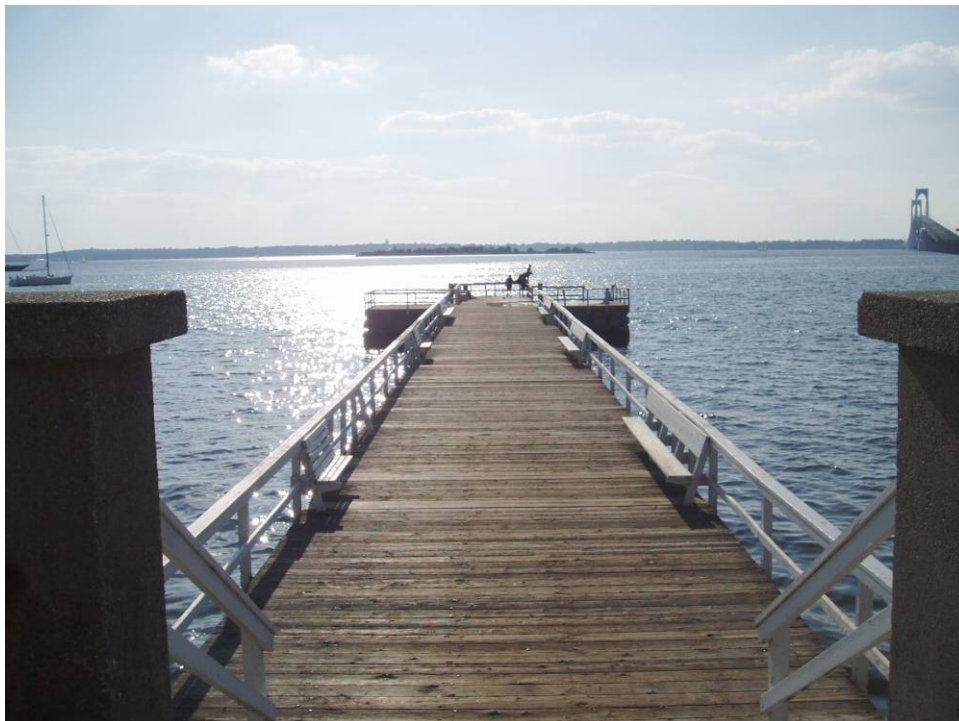
Photo 4. Looking out to Van Zandt Pier from the entrance.

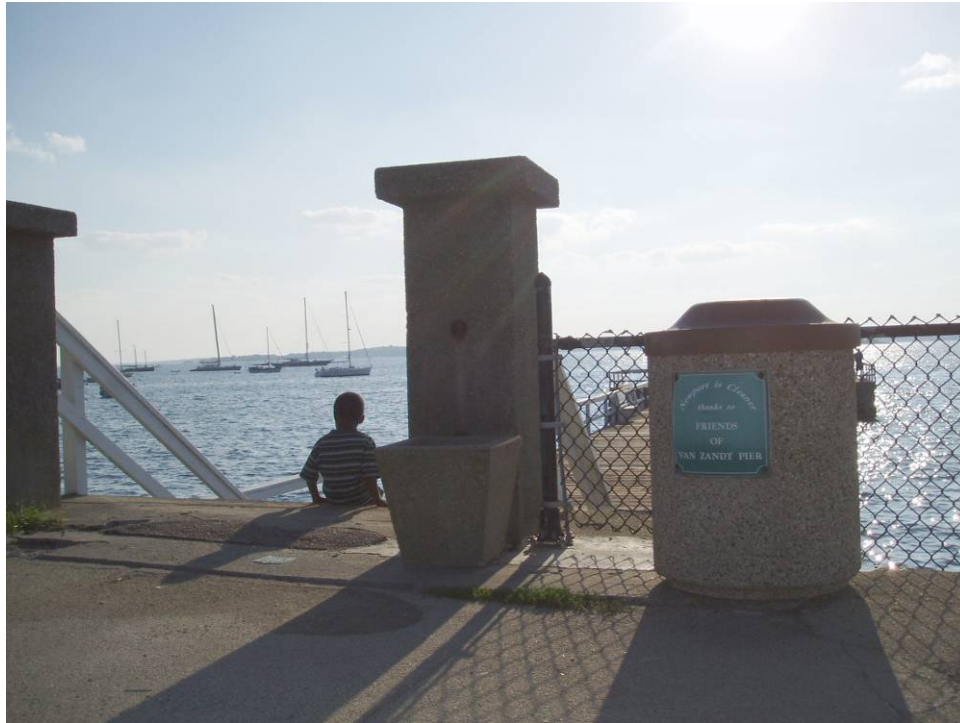
Photo 5. Entrance to Van Zandt Pier. The site is kept clean by the Friends of Van Zandt Pier as noted on the trash receptacle.

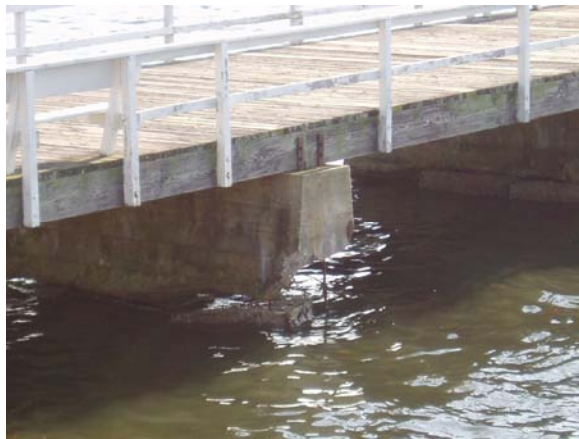
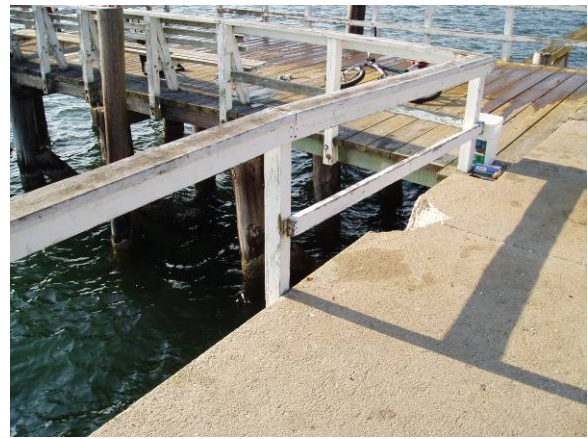
Photos 6A and 6B. Deteriorated condition of pier structure. Significant section loss (left) is typical for all concrete piers supporting timber deck sections of the pier.

While this evaluation does not constitute a structural inspection, the entirety of Van Zandt Pier appears to be in fair to poor condition, with the most significant deficiencies being section loss in the concrete piers which support timber-deck sections of the pier (see Photo 6A). The deck and superstructure elements also appear well worn from use and exposure to the elements, and portions of railings and benches are also missing in certain locations (Photo 6B).

Given the well-established residential uses which surround the Van Zandt Pier, the lack of public parking (or available land for the potential development thereof), and the presence of eel grass in the vicinity, the development of a longer or larger-capacity fishing structure at this location does not appear feasible. While in effect viable only for a local user base, the Van Zandt Pier site does provide good shoreline fishing access, both in its facilities and the quality of fishing at this location. However, given the current structural condition of the pier, the long-term sustainability of this CRMC public right-of-way is contingent upon the satisfactory rehabilitation or replacement of the existing structure. As such an endeavor could potentially be costly and complicated by the environmental constraints posed by the site, the State may wish to consider providing capital assistance to (or jointly administering a project with) the City of Newport for the rehabilitation of the Van Zandt Pier.

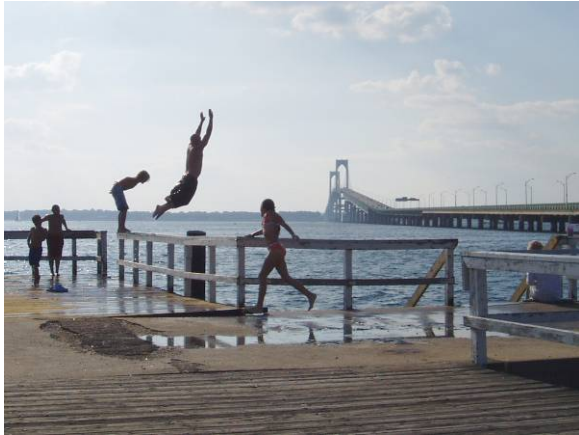
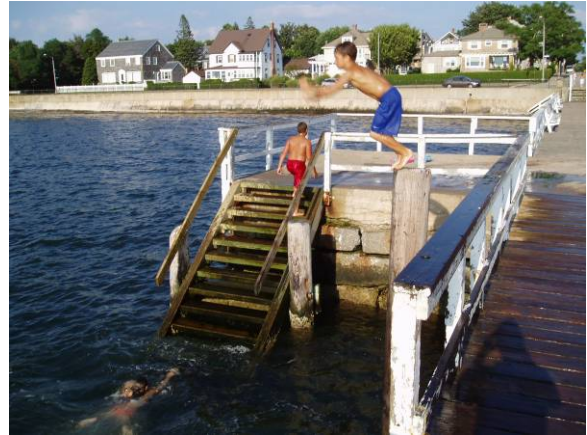
Photos 7A and 7B. Swimming use of Van Zandt Pier, including stairway on the northerly side of the pier.

As previously noted, the pier is also actively used by local children for diving and swimming (Photos 7A and 7B). In addition to being generally incompatible with fishing use of the pier due to the potential for injury, diving at the site is also inherently hazardous in itself, as there is no lifeguard at the site nor are there any other safety measures in place. One angler at the site noted that these uses seldom conflict, as swimming/diving at this site by children occurs primarily during the day, while fishing use of the site typically picks up in the evenings and continues into nighttime hours.

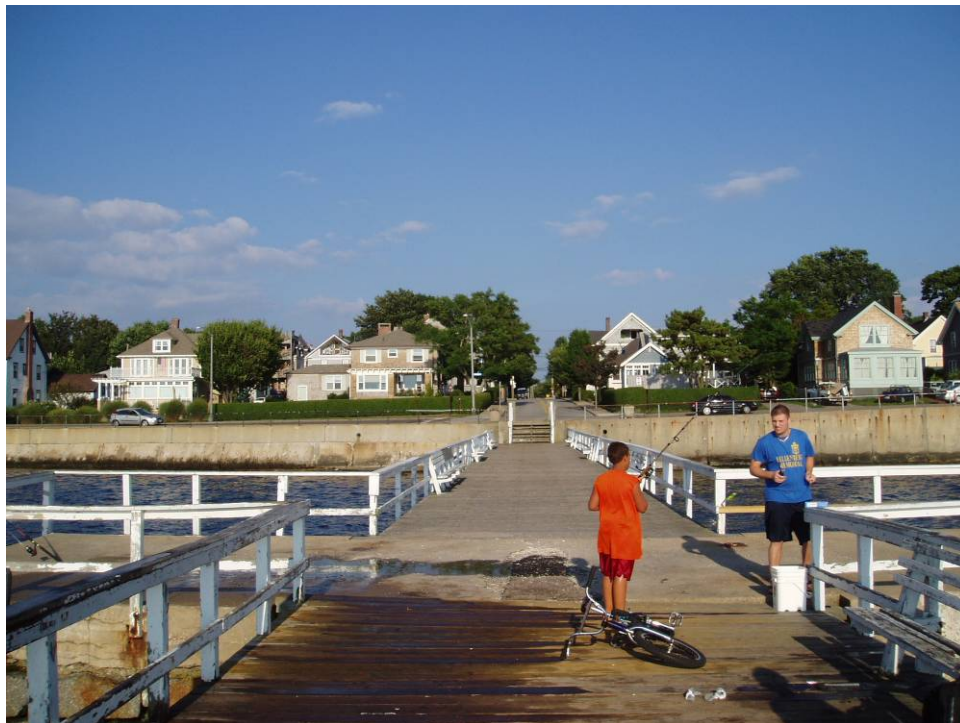
Photo 8. Looking east back along Van Zandt Pier.
